Manhole Inspection Summary

Manhole # S11MM_017MH

Location Address: **2208 ROSEDALE RD**

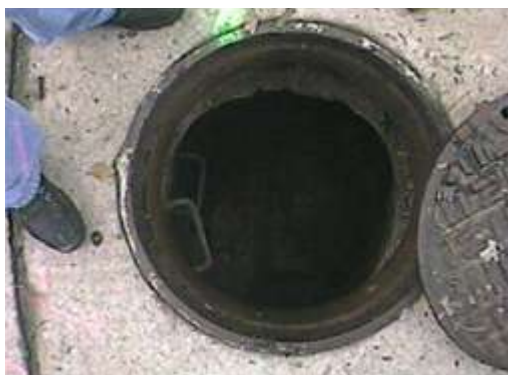
Top View

Frame Offset: **2** (in.) Condition: ☒ Sound ☐ Cracked ☐ Leaks

FRAME OFFSET

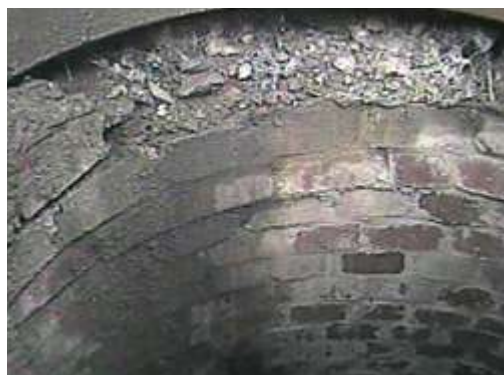
Defect 1

Condition: ☐ Sound ☐ Cracked ☐ Root Intrusion ☒ **Loose Brick** ☒ **Deteriorated**

LOOSE BRICKS ON ADJUSTMENT AND SOME DETERIORATION

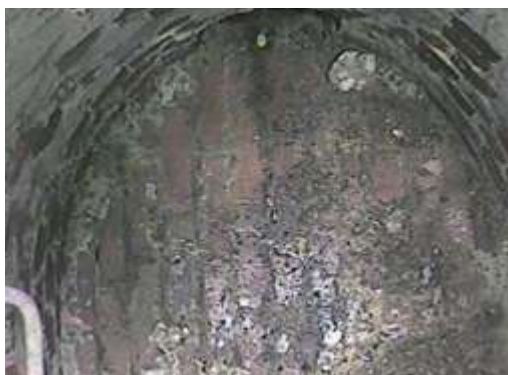
Defect 2

CHANNEL DEBRIS
